Manhole Inspection Summary

Manhole # S11EE_004MH

Location Address: **REAROF 3018 BELMONT AVE** Cross Street: **ROSEDALE ST**

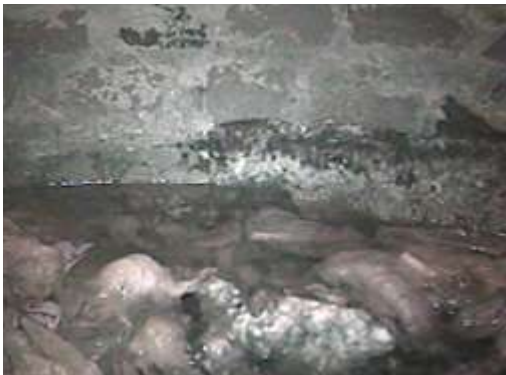
Defect 1

DEBRIS ON BENCH

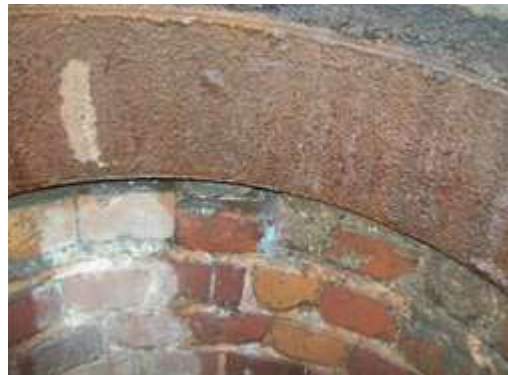
Defect 2

Condition: ☐ Sound ☒ **Cracked** ☐ Root Intrusion ☒ **Loose Brick** ☒ **Deteriorated**

DEBRIS IN CHANNEL

deteriorated chimney

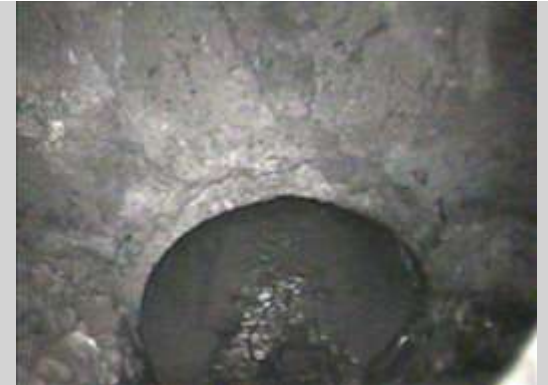
12 O'Clock Outflow

6 in. Circular Gravity Sewer
Pipe Out @ 12 O'Clock

Pipe Height: (in.) Direct
Pipe Material: **Clay** ☐ Pipe Lined
Invert Depth: **10.25** (ft.) Flow Characteristics: **Slow**
Deposits: ☐ None ☐ Mud ☐ Gravy ☒ Debris ☐ Grease
Silt Depth: **1** (in.) Deposits Extent: **Light**
Infiltration: **None** Pipe Seal Cond: **Sound**

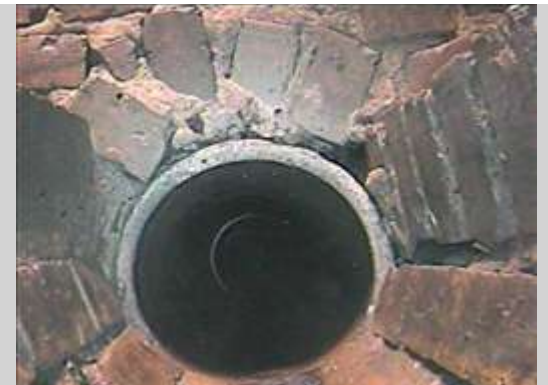
6 O'Clock Inflow

6 in. Circular Gravity Sewer
Pipe In @ 6 O'Clock

Pipe Height: (in.) Direct
Pipe Material: **Clay** ☐ Pipe Lined
Invert Depth: **9.86** (ft.) Flow Characteristics: **Slow**
Deposits: ☐ None ☒ Mud ☒ Gravy ☒ Debris ☒ Grease
Silt Depth: **6** (in.) Deposits Extent: **Heavy**
Infiltration: **Evidence** Pipe Seal Cond: **Unknown**
